**Flood Control Project Maintenance  
Levee Inspections**

**Maintenance Issue Types Only, Levee Inspection Report By Mile - Fall 2016**

**Sutter Maintenance Yard Hamilton Bend**

| Waterway | Bank | Unit Miles | Inspection Start/End | Inspector |
|---|---|---|---|---|
| Unit No. 01 Feather River Hamilton Bend | Right | 3.39 | 09/07/2016<br>09/07/2016 | Sterling York |

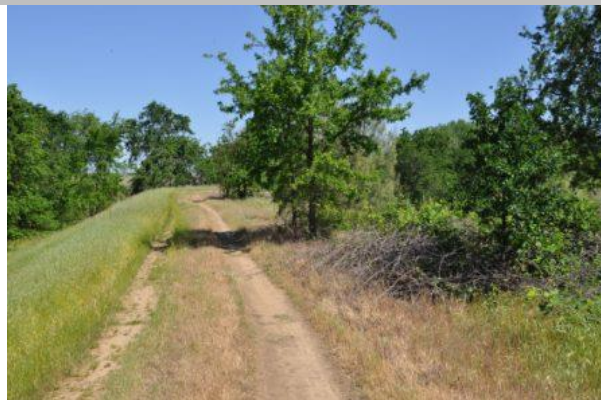
Photo 1 of 1 : FA\_2016\_ST0005\_289\_5\_20160906\_00002.jpg

| LM Start | 1.69 | Rating ** | M | Issue No. | 5 |
| Item | Trim / Thin Trees | | | 39.459451 ° | 39.469081 ° |

W/S trees 4" in diameter at chest height should be removed before they get to big..

| Trees smaller than 4" in diameter at chest height should be removed before they get any bigger. | | | | | |

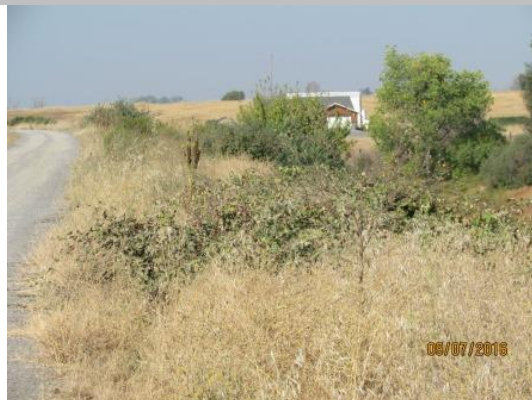
Photo 1 of 1 : FA\_2016\_ST0005\_289\_10\_20160912\_00014.jpg

| LM Start | 2.46 | Rating ** | M | Issue No. | 10 |
| Blackberry bushes are covering landside slope. | | | | | |

View of blackberries that are covering landside slope.

| V2 : Remove the wild growth other than native grasses from the levee slopes. | | | | | |

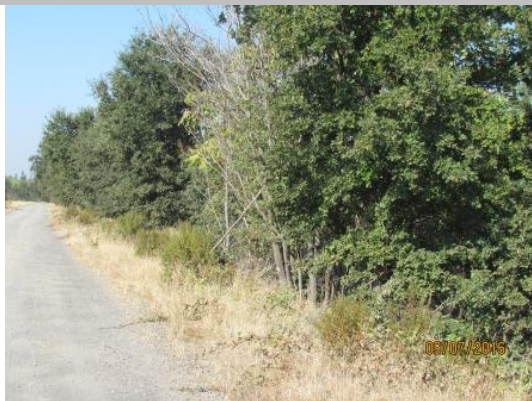
Photo 1 of 1 : FA\_2016\_ST0005\_289\_3\_20160912\_00011.jpg

| LM Start | 2.53 | Rating ** | U | Issue No. | 3 |

Very dense trees and limbs that completely obstruct visibility and flood fight access to the levee slope and the landside easement.

| T2 : Thin trees to allow visibility of the ground and room to flood fight. | | | | | |

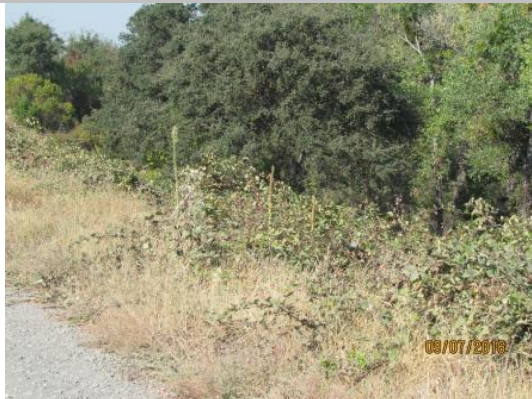
Photo 1 of 1 : FA\_2016\_ST0005\_289\_6\_20160912\_00013.jpg

| LM Start | 2.63 | Rating ** | U | Issue No. | 6 |
| Blackberries covering slope. | | | | | |

View of blackberries that are covering the landside slope.

| V2 : Remove the wild growth other than native grasses from the levee slopes. | | | | | |

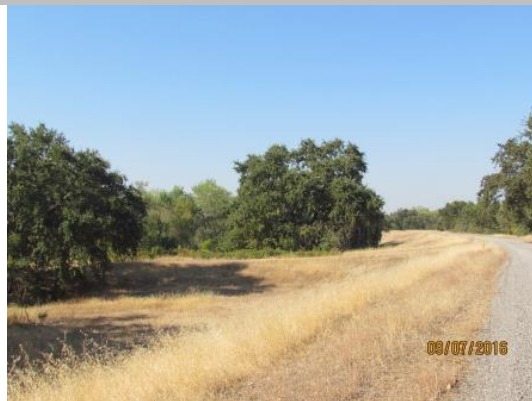
Photo 1 of 1 : FA\_2016\_ST0005\_289\_23\_20160912\_00012.jpg

| LM Start | 2.93 | Rating ** | M | Issue No. | 23 |
| Annual grasses need to be maintained. | | | | | |

View of annual grasses that need to be maintained.

| V1 : Control annual grass and weeds on the levee slopes and easements. | | | | | |

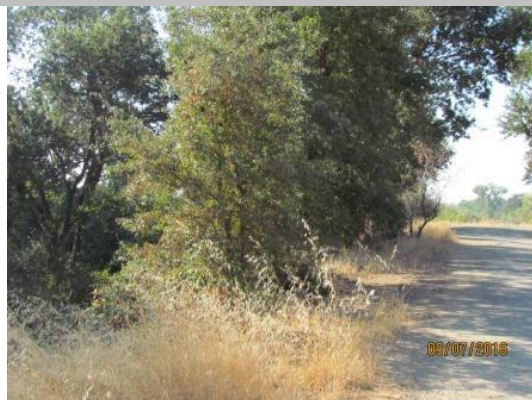
Photo 1 of 1 : FA\_2016\_ST0005\_289\_4\_20160912\_00010.jpg

| LM Start | 3.26 | Rating ** | M | Issue No. | 4 |
| Small trees 4" in diameter at chest height should be removed before they get to big. | | | | | |

Waterside trees. Small trees 4" in diameter at chest height should be removed before they get to big.

| T3 : Trim and thin trees to allow visibility of the ground and room to flood fight. | | | | | |
